**INSTALLATION RESTORATION PROGRAM
PHASE II - CONFIRMATION/QUANTIFICATION
STAGE 1**

CANNON AFB, NEW MEXICO 88103

FINAL REPORT
FOR
CANNON AFB, NEW MEXICO

VOLUME 1. TEXT

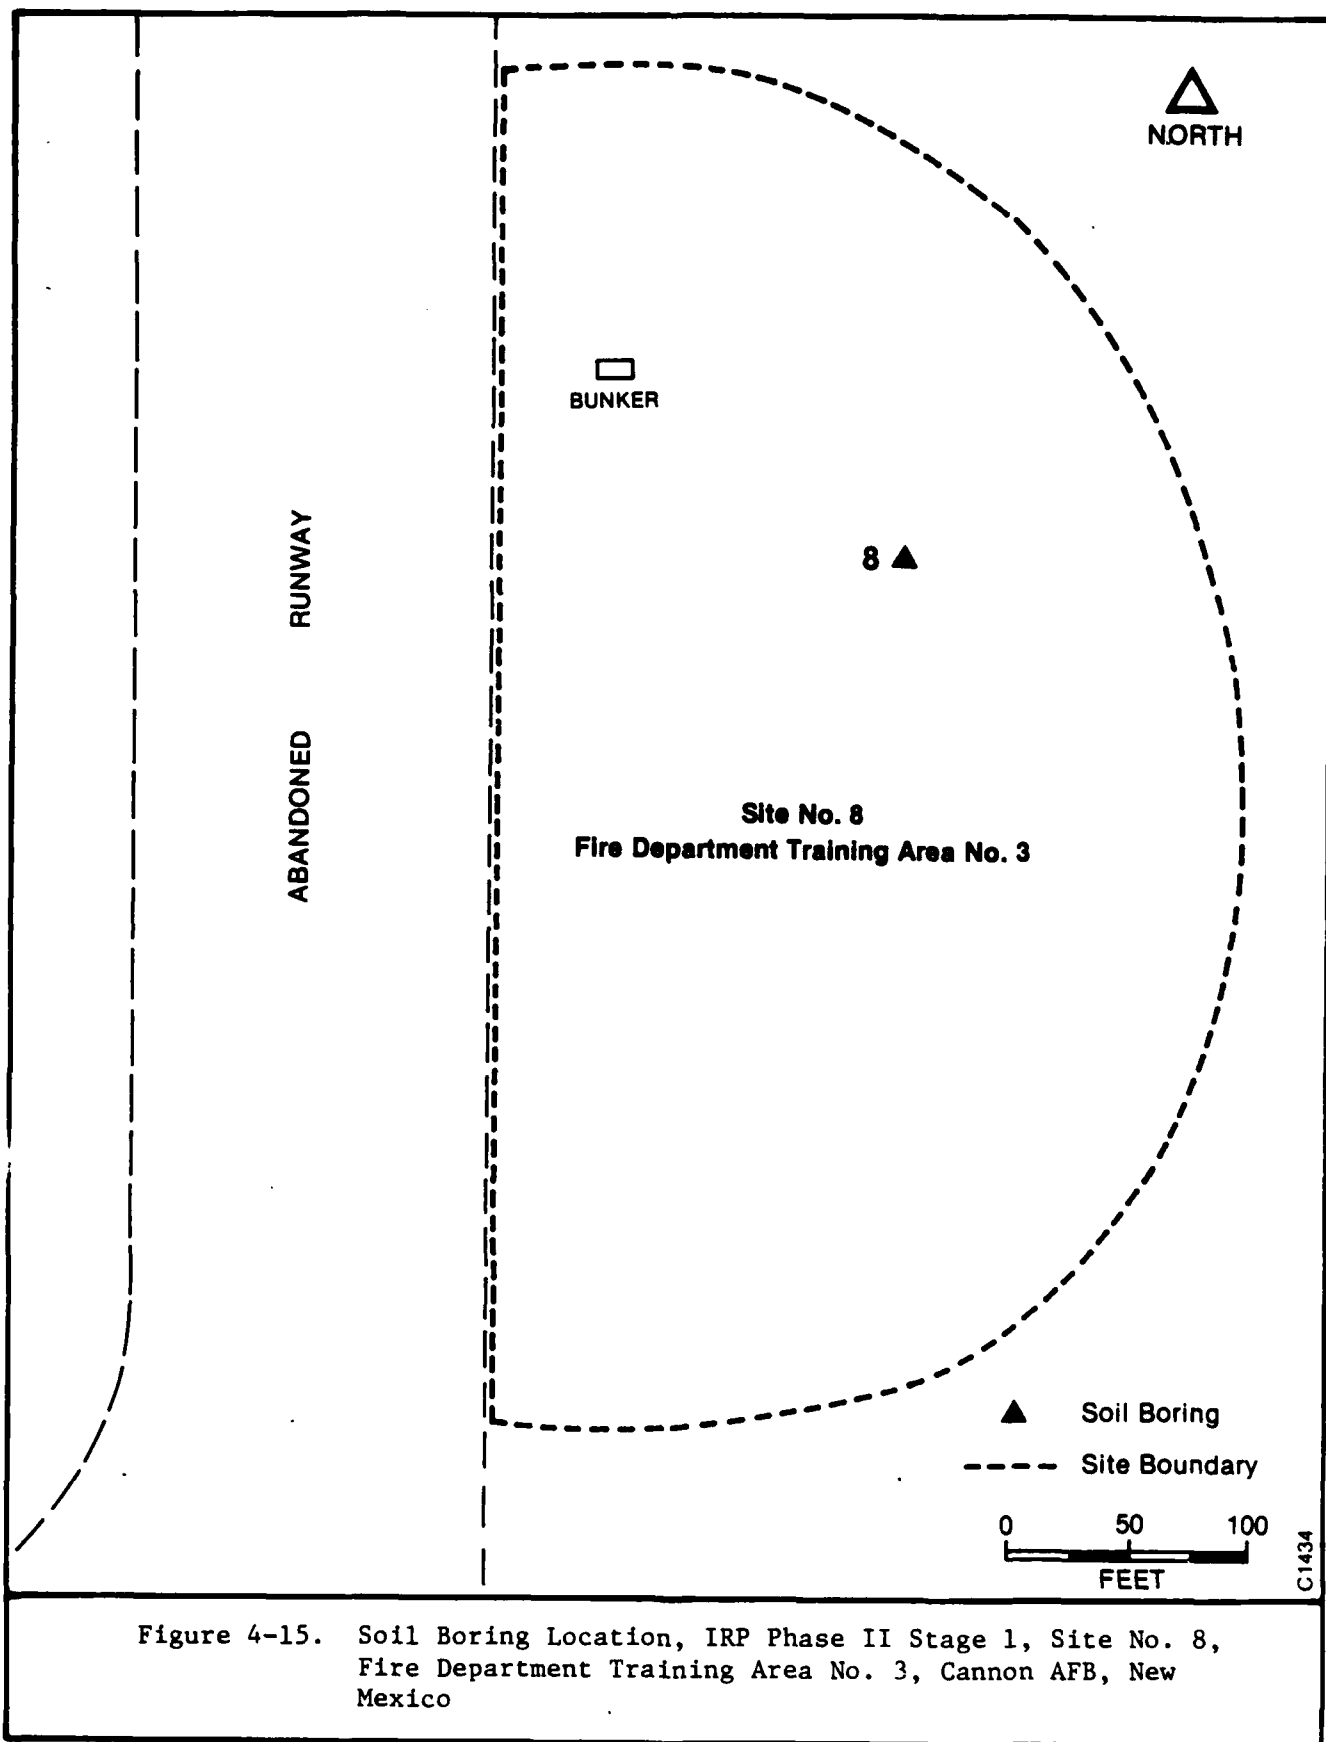
Figure 4-15. Soil Boring Location, IRP Phase II Stage 1, Site No. 8, Fire Department Training Area No. 3, Cannon AFB, New Mexico

in the lowest portion of the site where the greatest amount of contaminants were expected to accumulate. A low berm (less than one foot high) encircles the site and forms the site boundary for the fire training area. Drainage in the site is to the southeast, and is achieved through overland flow. There are no defined drainages in the vicinity.

No trend can be defined based on three samples. However the surface sample contained the least oil and grease of the three. Fire training activities at the site would tend to initially saturate the surficial soils to a greater degree than the underlying caliche. It is likely that combustible materials in the shallowest zone would be more completely consumed than those that percolated to slightly greater depth. This would account for the observed increase in oil and grease between the shallowest and intermediate samples and decrease from the intermediate to deepest sample, beyond the likely range of downward migration.

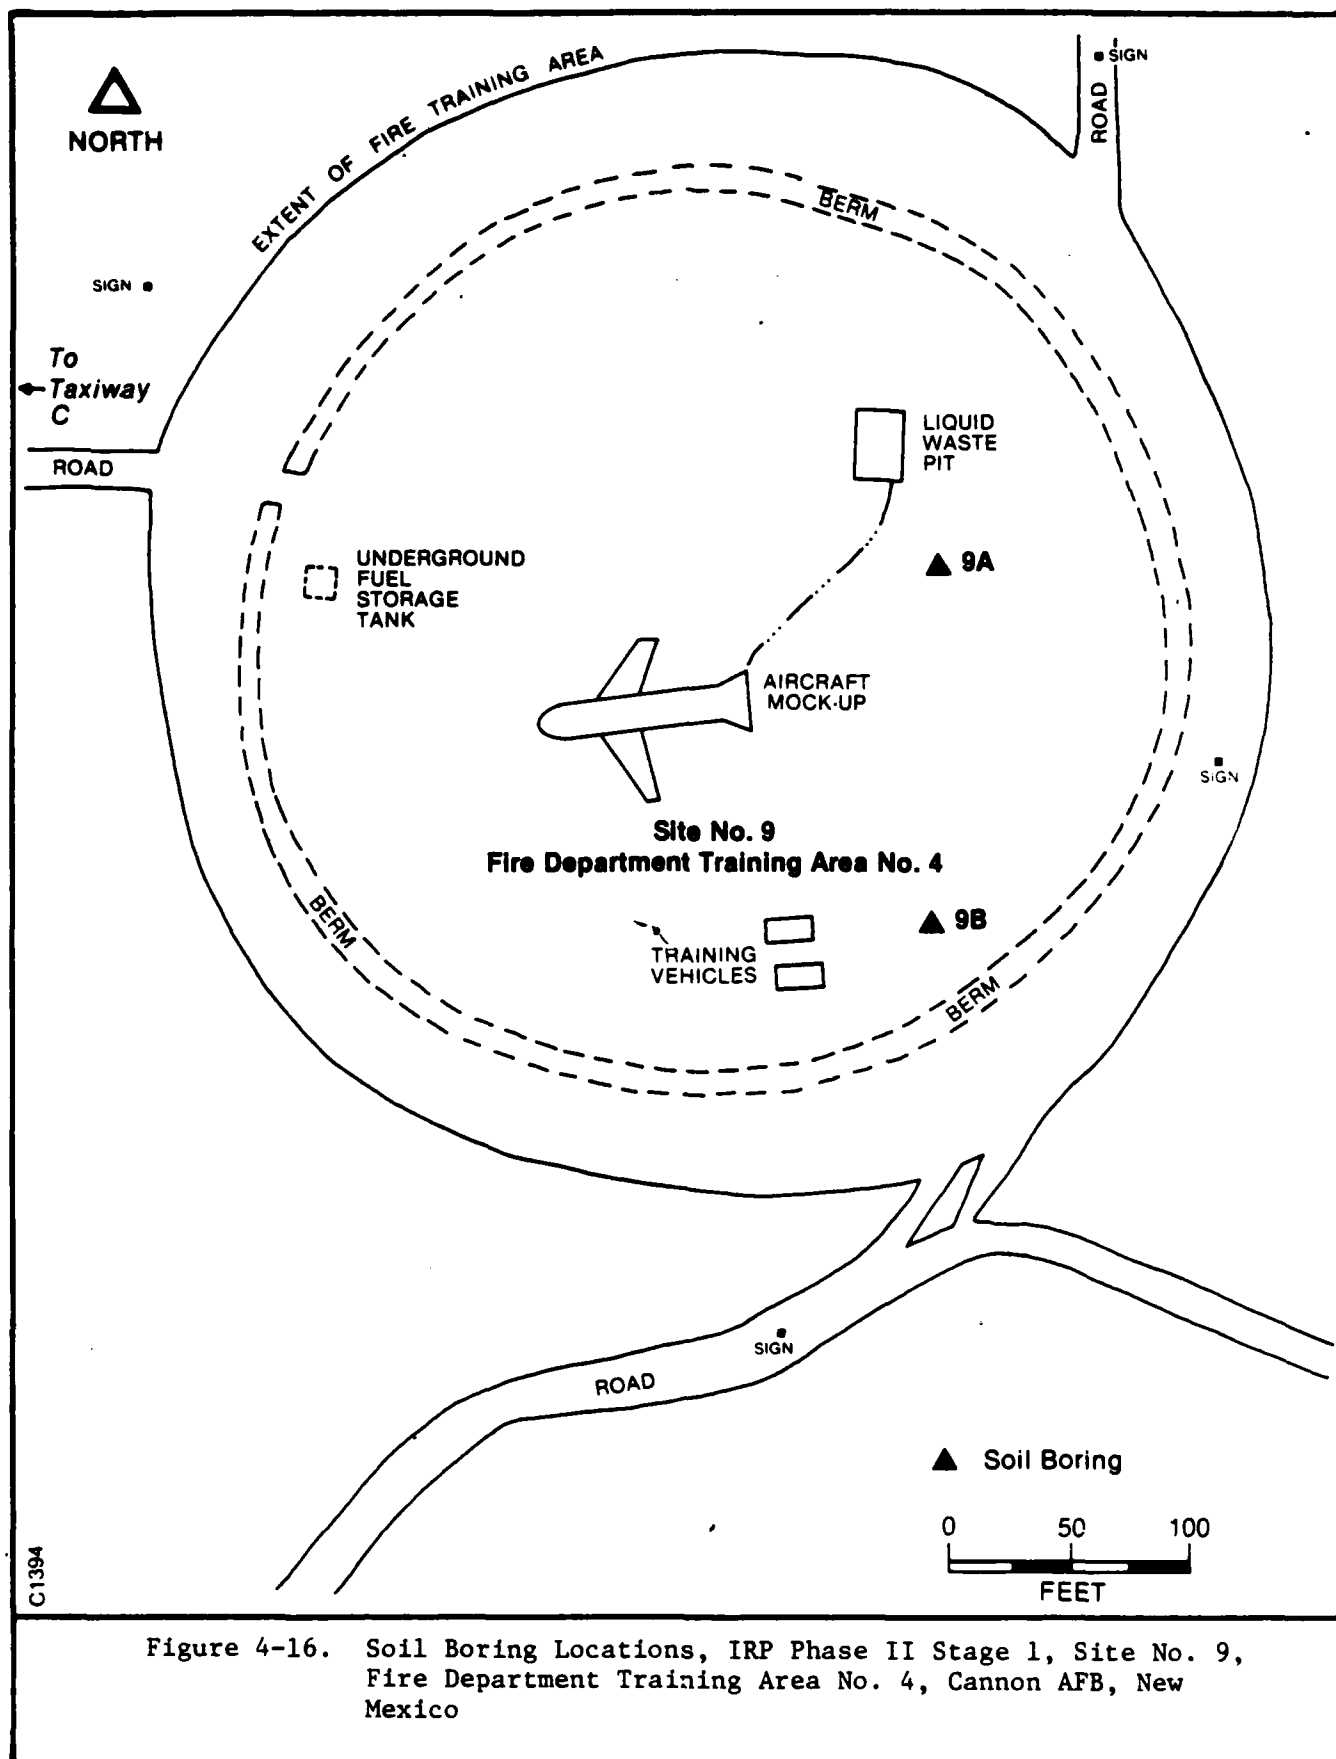
Figure 4-16. Soil Boring Locations, IRP Phase II Stage 1, Site No. 9, Fire Department Training Area No. 4, Cannon AFB, New Mexico

The training site is a shallow unlined circular depression, approximately 400 feet in diameter. A simulated aircraft sits at the center of the burn pit. A 2,000-gallon underground tank installed in 1975 is used to store recovered JP-4 fuel for burning. The fuel is pumped from the storage tank to the simulated aircraft prior to practice burns. Runoff from the area is collected in an unlined pit adjacent to the site. Visual evidence of surface contamination at this site was reported during the Phase I survey. In 1985, this facility was rebuilt. A new lined facility with an oil/water separator was installed to handle collected runoff.

Five soil samples were collected from Fire Training Area No. 4 and analyzed for the following: oil and grease, lead, and purgeable halocarbons and aromatics. The data are summarized in Table 4-13. None of the samples contained purgeable aromatics or halocarbons in detectable quantities when tested. Lead values ranged from 1.3 mg/kg to 39 ug/g. The highest lead concentration was found in soil boring 9A-2, collected 5 feet into the caliche layer, however, the duplicate sample (9A-2A) contained only site background levels of lead. The lowest value was from the deepest sample (9B-3) collected below the caliche profile.

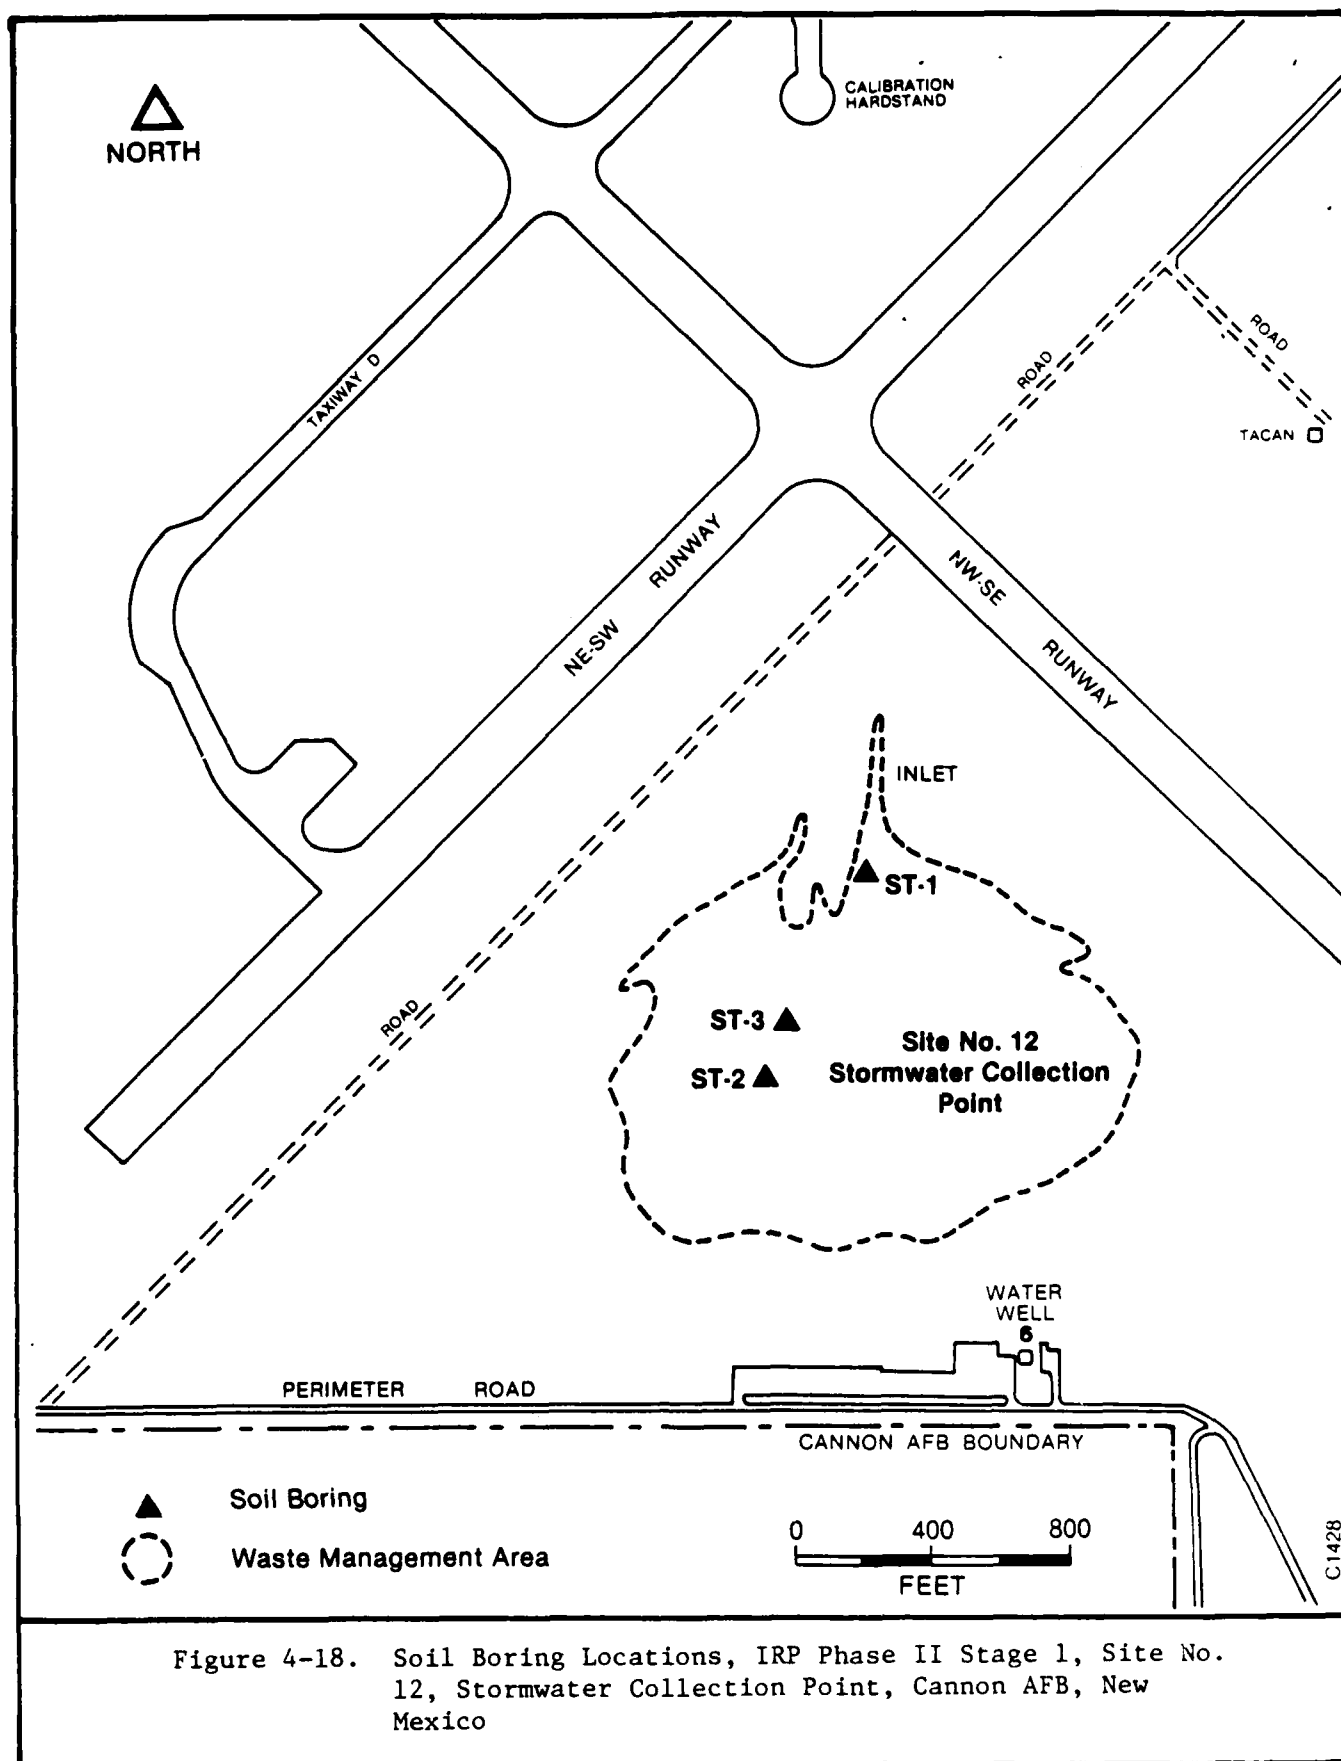
This site was included for study in the Phase II Stage 1 program primarily because of the suspected disposal of small amounts of hazardous materials and the existence of a drinking water well (No. 6) within 800 feet (Figure 4-18). Three shallow (5 ft) hand-augered boreholes were made at Site No. 12. Samples were collected at a depth of one foot and five feet, and analyzed to determine whether environmental contamination has occurred. Two sites were positioned near the center of the basin. Another site was located near the inlet to the Stormwater Collection basin. The soil, debris and clay in the catchment basin was completely saturated with water forming a type of

"quicksand" at about 4 feet in depth. Saturated conditions prevented the retrieval of any samples beyond 4 feet in depth, therefore, only one sample per shallow auger hole was retrieved for analysis.

Variable metals concentrations were found in the three samples collected at Site No. 12. The concentration of heavy metals, especially lead, appears to increase toward the center of the basin. The environmental significance of this trend cannot be fully evaluated based on existing data. The vertical extent of the clay- debris layer on the basin bottom could not be determined, therefore, it is unclear where the first confining caliche or sand layer lies. Further investigation for lead may be required for this site.

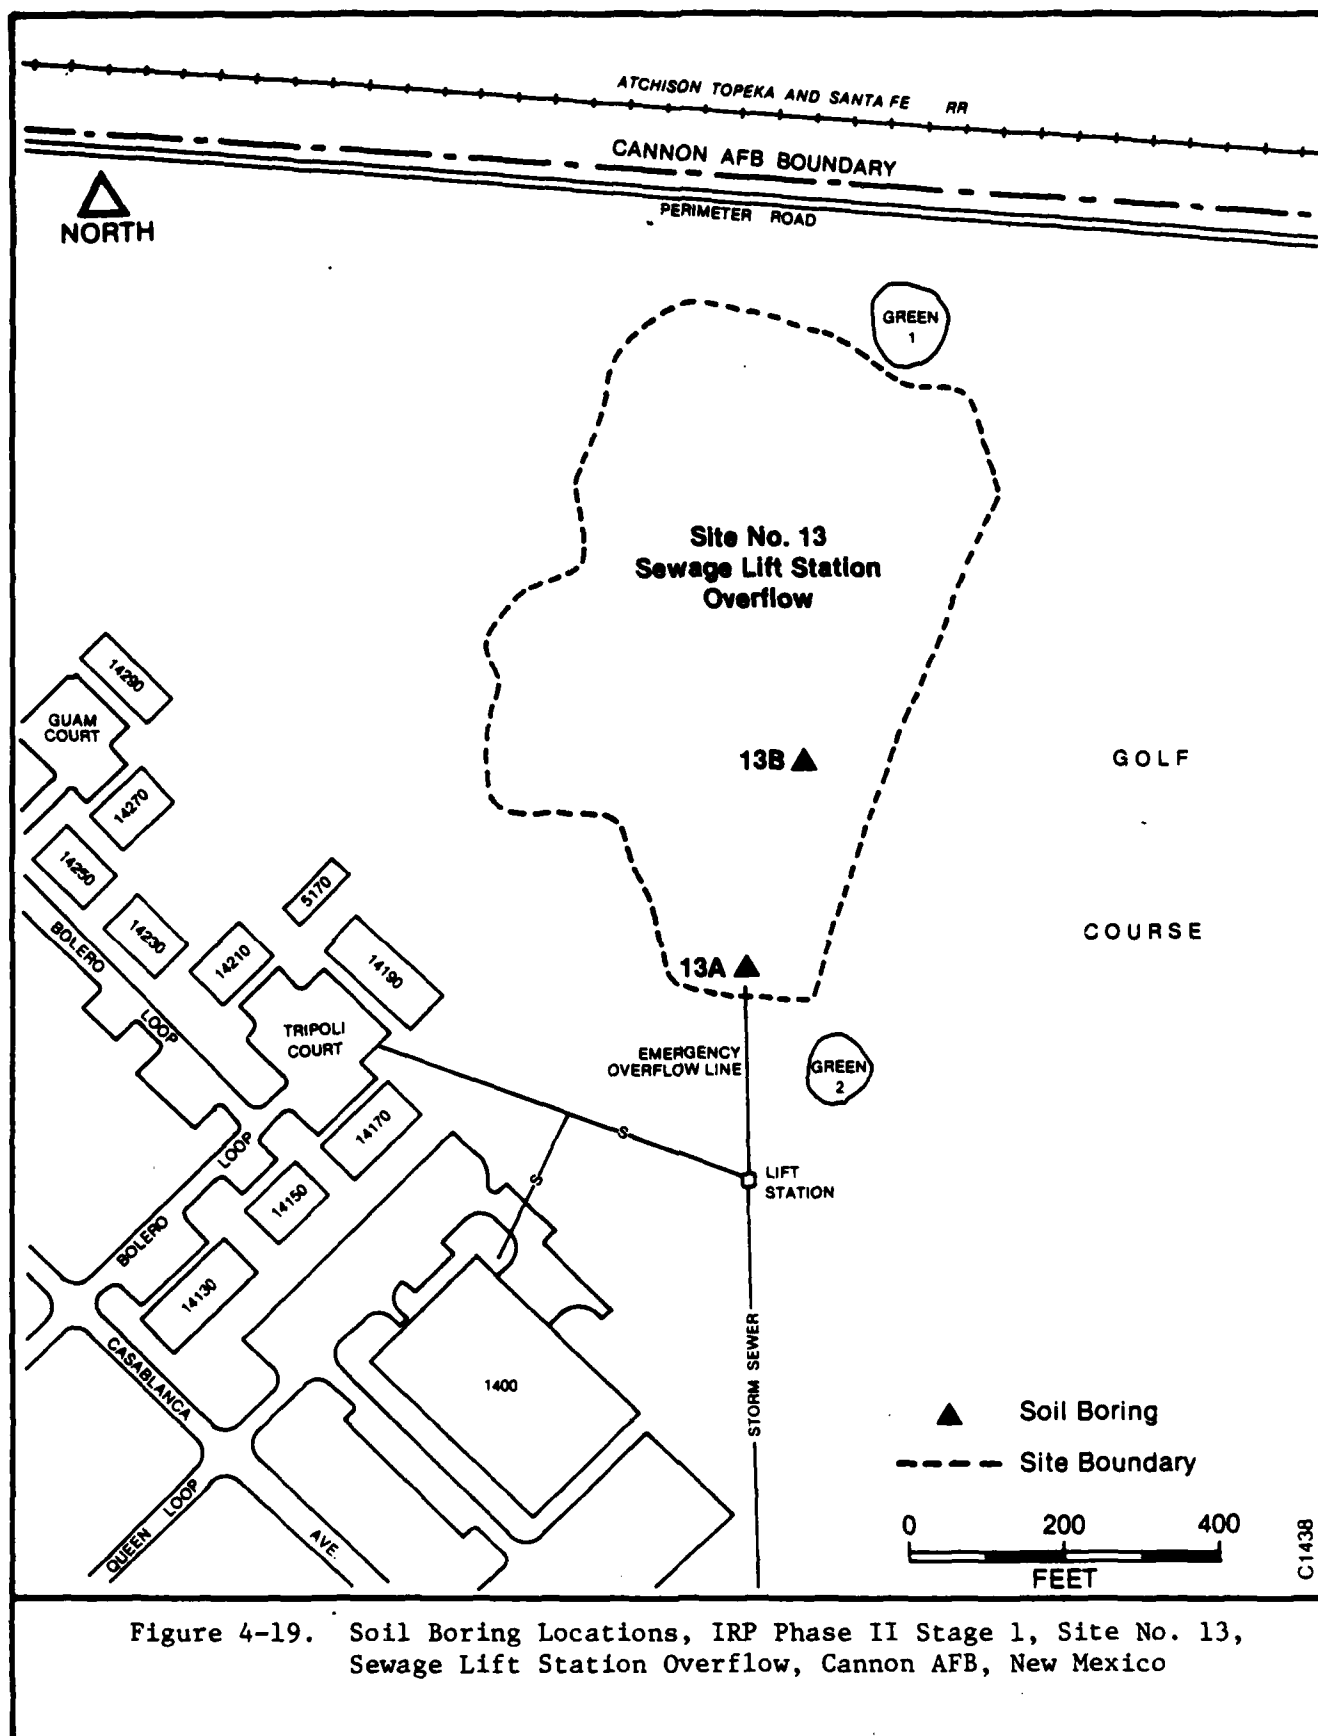
Figure 4-19. Soil Boring Locations, IRP Phase II Stage 1, Site No. 13, Sewage Lift Station Overflow, Cannon AFB, New Mexico

Site No. 13 is an overflow pit, approximately 100 feet x 600 feet 2 to 3 feet deep, located on the golf course, north of the base hospital. It appears as a rectangular, grass-covered depression (Figure 4-19). The pit was designed specifically for emergency use. In February, 1983, such an emergency occurred when the pumps in Sanitary Lift Station No. 1402 malfunctioned and an estimated 100,000 to 150,000 gallons of raw sewage were bypassed to the pit. One week later, the pumps were repaired and the sewage was cycled back to the lift station. Initial sample results reflected that material (hazardous by EPA ignitability criterion) may have been in the sewage diverted to the Overflow Pit.

Analytical results for the soil samples from Site No. 13 are presented in Table 4-16. No volatile organics (EPA 8010 and 8020) were detected in any of the samples collected. Metals values are variable but generally within the normal range for soils (Table 4-3). Somewhat higher levels of barium and manganese were found in soil boring 13B, relative to the other samples. Oil and grease was found in all samples at relatively low levels ranging from 26 mg/kg to 67 mg/kg.

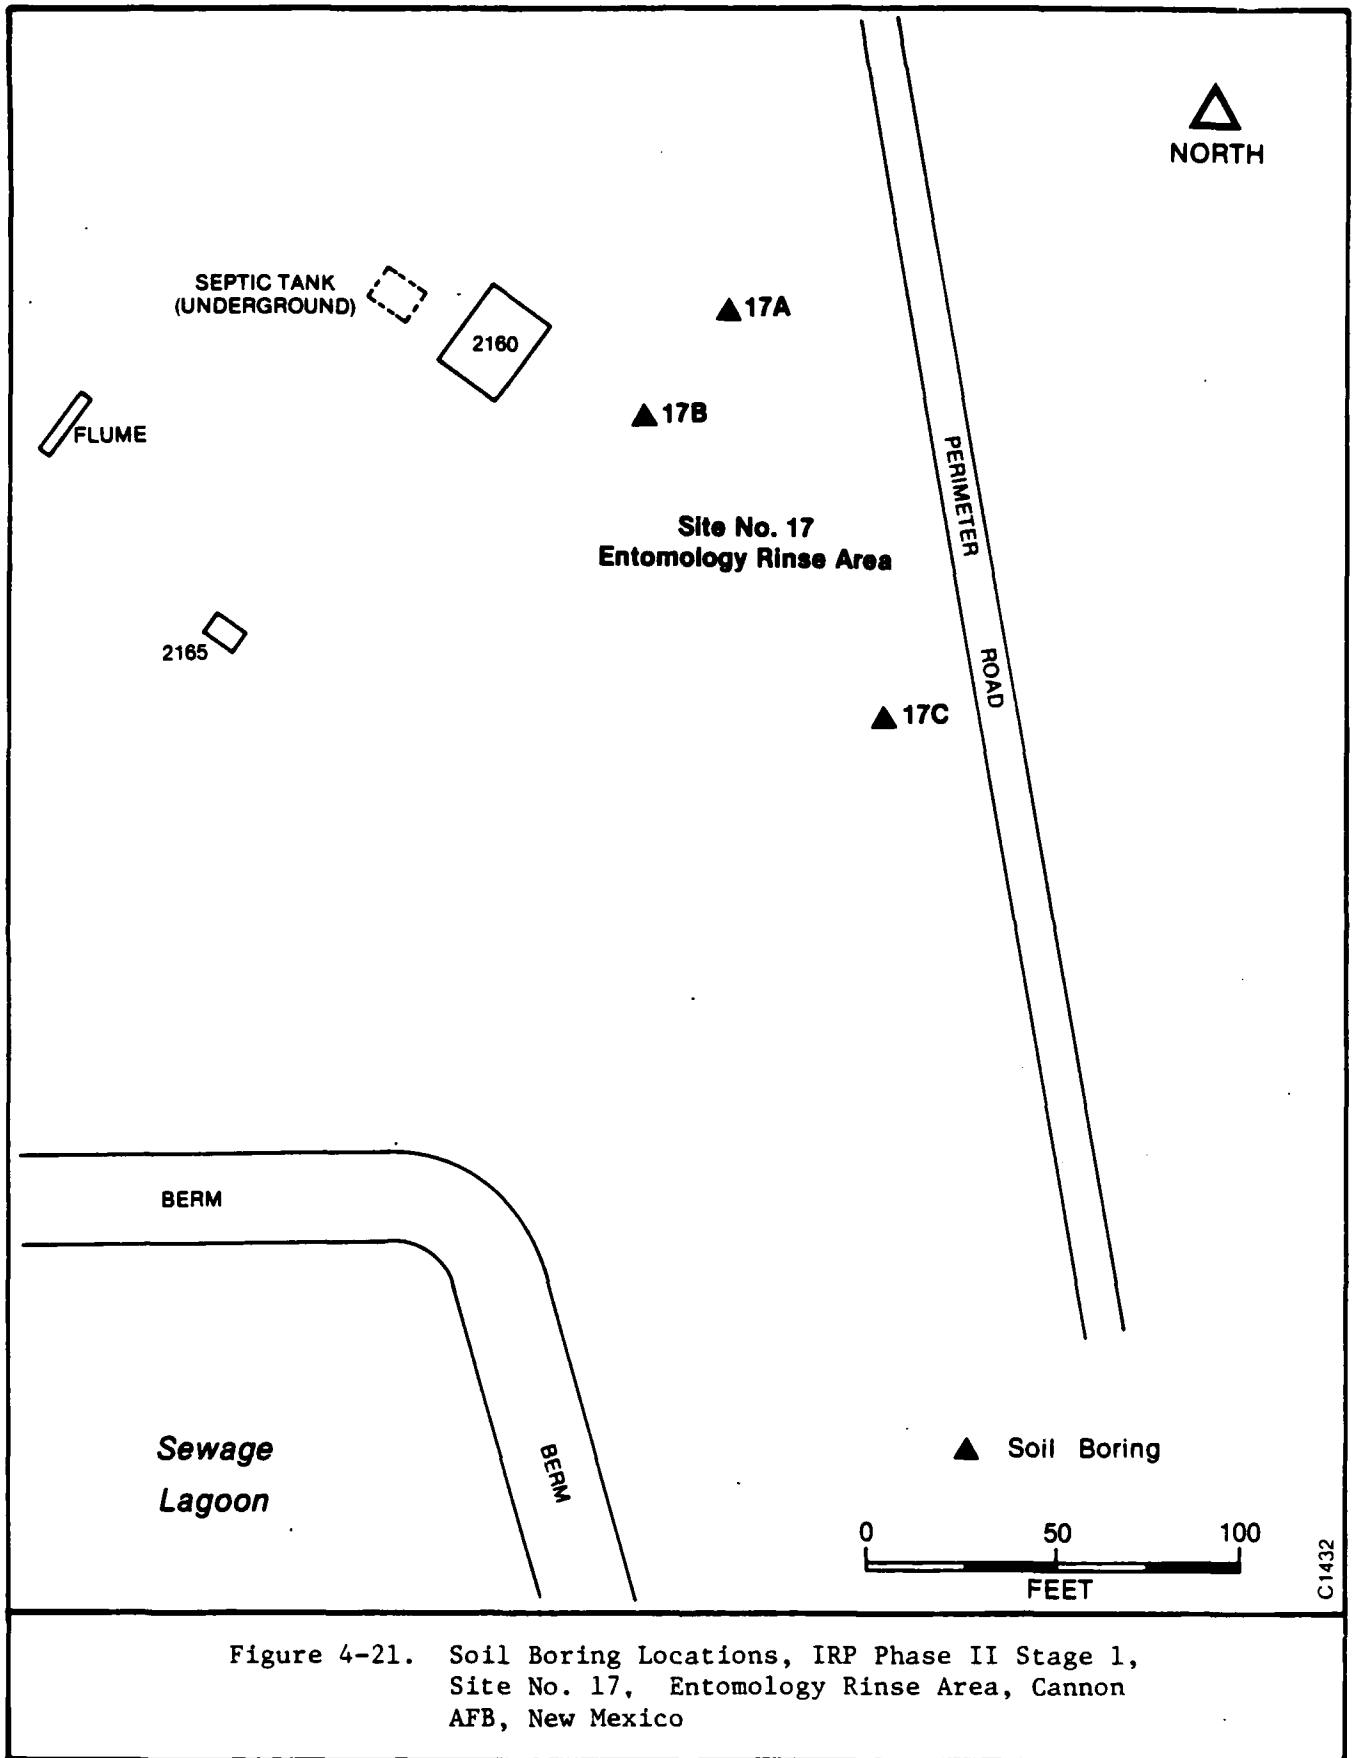
Figure 4-21. Soil Boring Locations, IRP Phase II Stage 1, Site No. 17, Entomology Rinse Area, Cannon AFB, New Mexico

The Entomology Rinse Area is located behind a pesticide storage building (No. 2160) (Figure 4-21). Rinse water from decontaminating pesticide spraying equipment and empty containers drained from the building through a sink that discharged into a small 3' x 3' x 2' open pit in the rear. The pit was within 5 feet of Building 2160.

Soil and gravel in the base of the pit prevented determination of the nature and condition of the bottom. It is not known whether pesticides that drain into the pit are contained or percolate into the ground. Cannon AFB Real Property records indicate a new facility (Building 212) was constructed and occupied 19 October 1983. It is not known how long Building 2160 or its drain were in use. Building 2160 was demolished on 6 September 1984.

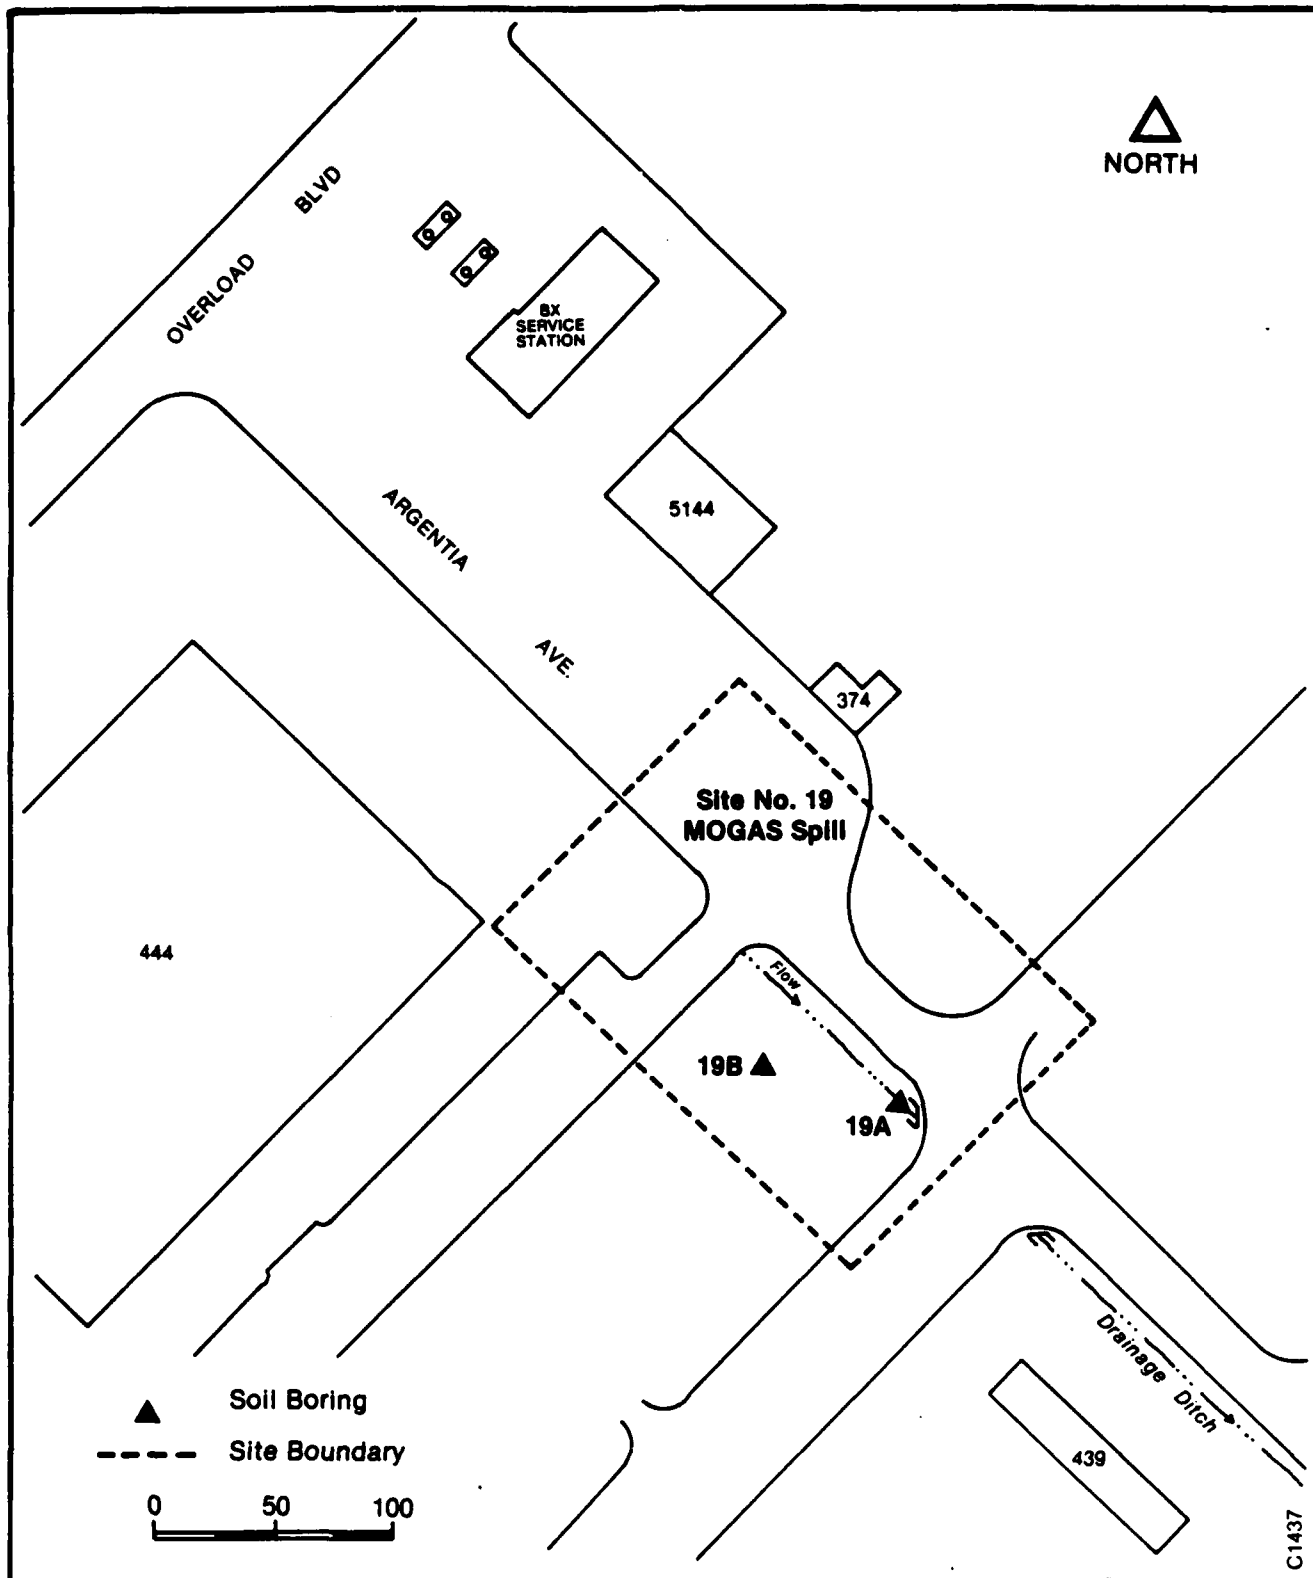
Figure 4-22. Soil Boring Locations, IRP Phase II Stage 1, Site No. 19, MORGAS Spill, Cannon AFB, New Mexico

Two deep soil borings were made at this site to define the local hydrogeologic setting and to evaluate the environmental impact of the MOGAS spills (Figure 4-22).
